# Manhole Inspection Summary

Manhole # S250\_\_006MH

Insp Date: **4/2/08 11:25 AM**

**Location** Address: **1402 Carrol St**

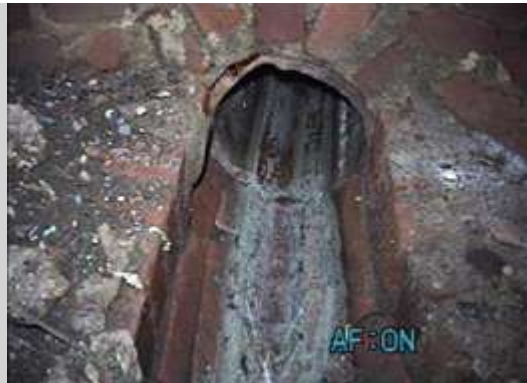
9 O'Clock Inflow

Pipe Height: **8.4** (in.) Rod and Bar (Angled)

Pipe Material: **Clay** ☐ Pipe Lined

Infiltration: **None** Pipe Seal Cond: **Sound**
